ANNUAL INSPECTION REPORT

NEARMAN CREEK POWER STATION

BOTTOM ASH IMPOUNDMENT

22 DECEMBER 2020

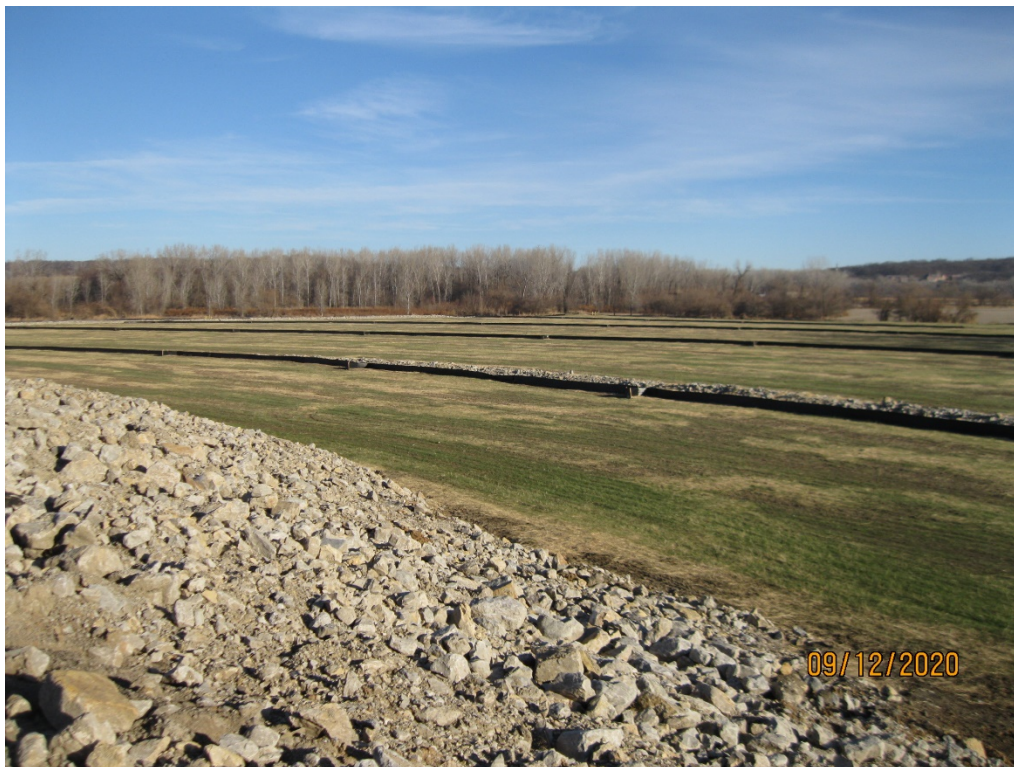
Figure 1 – Closure Grading for Bottom Ash Impoundment Areas

The Construction Quality Control Plan drawings show that the former impoundment embankments were used to regrade the area and facilitate surface water runoff. The riprap was reused to provide erosion protection of slopes and swales. The annual inspection observed the new grass and erosion protection fencing that was in place to provide protection for surface vegetation.

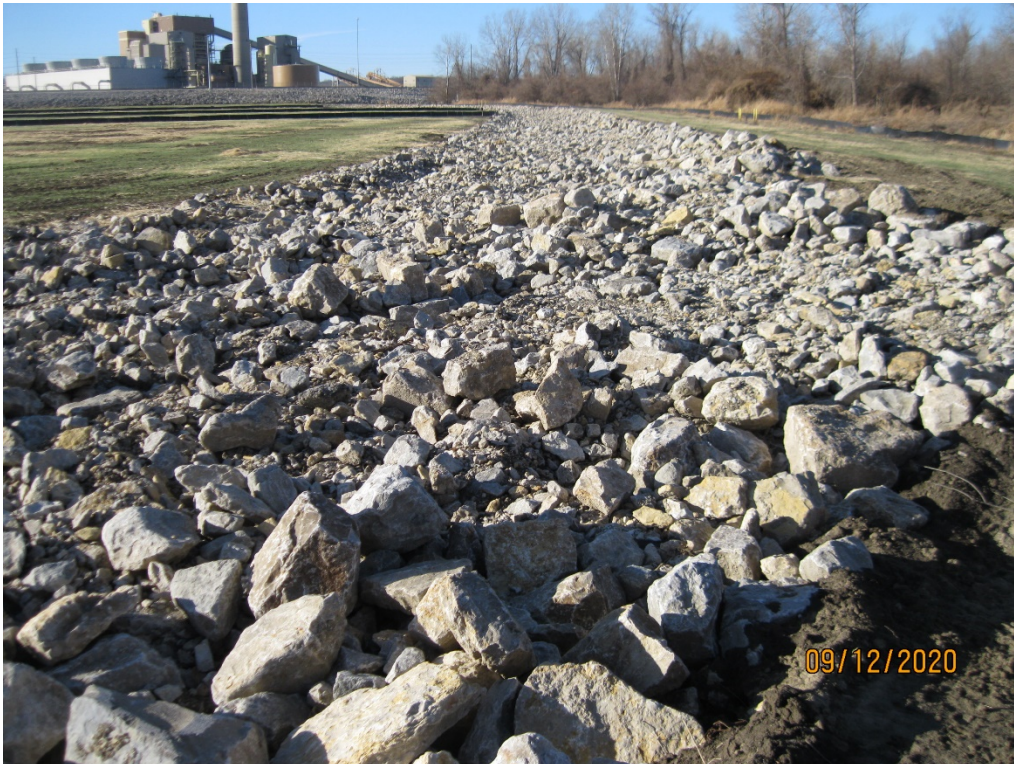
Figure 2 – Previous Location of Discharge Structure

The discharge structure that has been part of the impoundment had been demolished and the surface water drainage appears to have been directed toward the low areas downstream of the discharge structure location.

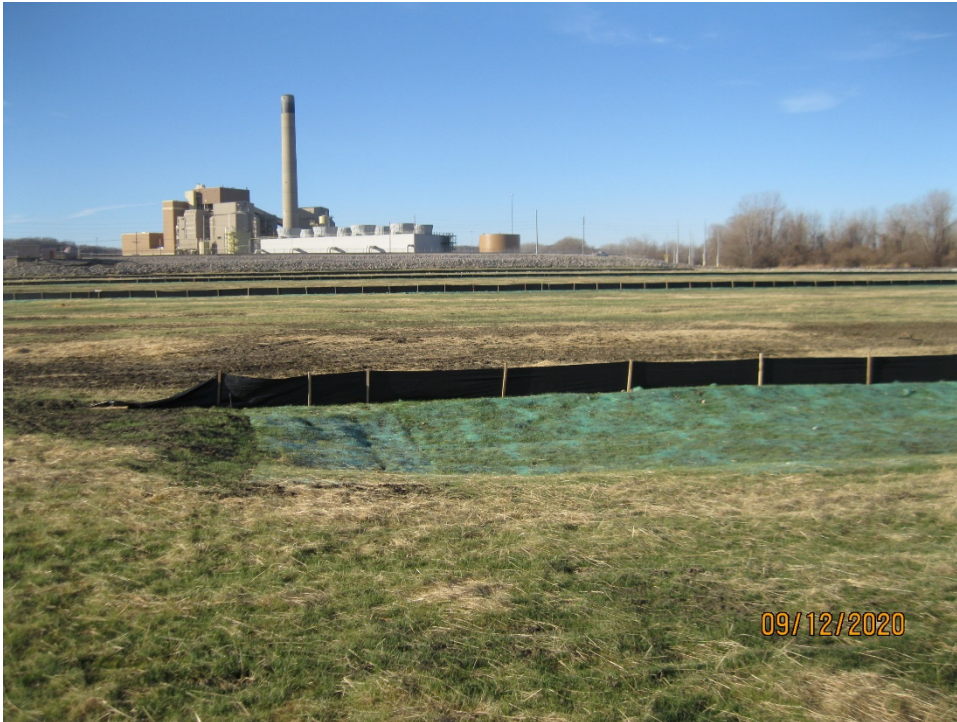
Figure 3 – Graded impoundment area – From east looking northwest.

The Construction Quality Control Plan drawings show the former impoundment area fill surface to slope toward the northeast corner which was the previous location of the discharge structure. The drawings indicated the fill grades range from Elevation 752 on the west to Elevation 742 at the northeast corner. Elevation measurements were not recorded for this inspection and the satisfactory completion of the construction has been provided in the Construction Quality Control Report.

The impoundment area does not retain water or bottom ash. The bottom ash removal has been documented in the Construction Quality Control Report.
